QOR.32 & QOR.16 Integrated Console Engine Software Package v2.2.0.177 – Update Instructions For iQ, Radius, RAQ + DESQ consoles June 2017, Cleveland, Ohio USA

Release Notes – v2.2.0.177

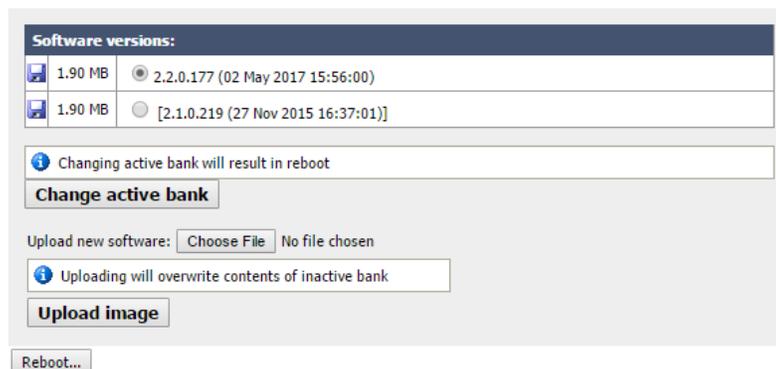
Software update:

1. Open the QOR web page at the unit's base IP address (standard HTTP port 80).
2. Visit the Setup page. Via the setup page, locate the “Browse” button and select the update file from the file system of your PC. The new version will load into the unused software bank once you press the “Upload image” button.
3. The page will refresh once the upload is complete, showing the new version in the unused bank. Now select the bank and press the “Change active bank” button.

The screenshot shows a web interface for software management. At the top, there is a section titled "Software versions:" containing a table with two rows. The first row shows a file size of "1.90 MB", a radio button selected next to the version "2.2.0.177 (02 May 2017 15:56:00)", and a second radio button next to "[2.1.0.219 (27 Nov 2015 16:37:01)]". Below the table is a warning message: "Changing active bank will result in reboot" with an information icon. Underneath is a button labeled "Change active bank". Further down is an upload section: "Upload new software:" followed by a "Choose File" button and the text "No file chosen". Below that is another warning: "Uploading will overwrite contents of inactive bank" with an information icon, and an "Upload image" button. At the very bottom of the interface is a "Reboot..." button.
