Axia iQx version 1.1.2

6 May, 2019, Cleveland, Ohio USA

Preparation for Update

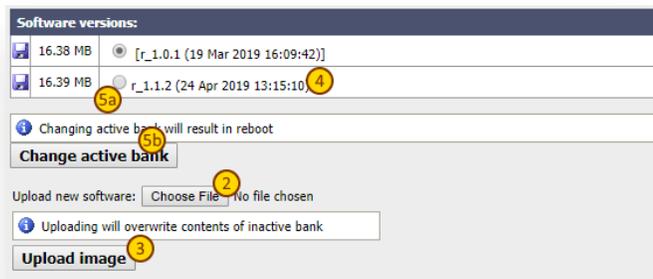
The software version in each bank is displayed from the Setup web page. The lower half of this screen, pictured below, shows the software versions present and allows you to select what bank will be used at startup. To change banks simply click the radio button for the desired bank and then click on *Change active bank*.

1. Visit <http://www.telosalliance.com/Axia/iQx> and click the V1.1.2 link under the **Software** tab on the right to download the update to your computer (this should be the computer that you will use to access the iQx’s web page).
2. Open a web browser and connect to the iQx to be updated. Select the *Setup* link. From the Setup page, select the *Choose File* button to locate the file. Once the proper file is selected, the filename will be displayed next to the button.
3. Click on *Upload image* to upload the file to the non-active bank.
4. A successful upload will be indicated by the new version being displayed in the non-active bank.
5. Click the radio button for the bank and click *Change active bank* to reboot and make the bank active.
