## Telos Zephyr iPort + TZD Software v2.1.0 Update Instructions and Release Notes

08 December 2016

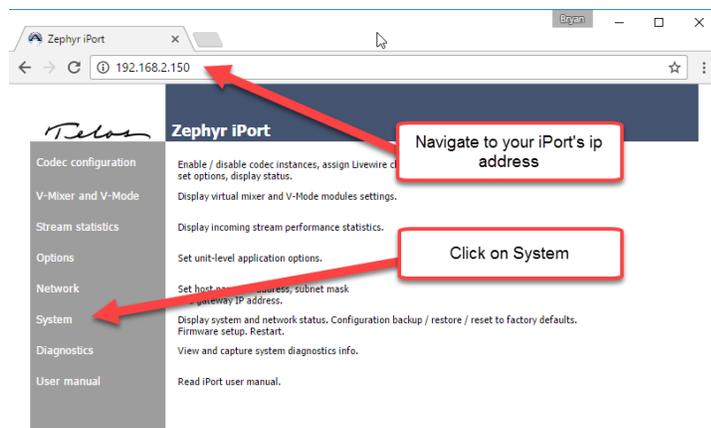
To determine your current version, open a web browser on a computer connected to the same network as your iPort, in the address bar type in the IP address of your iPort. In the example shown below, the ip address is 192.168.2.150. If prompted, enter the username and password for your iPort (the default is user with no password).

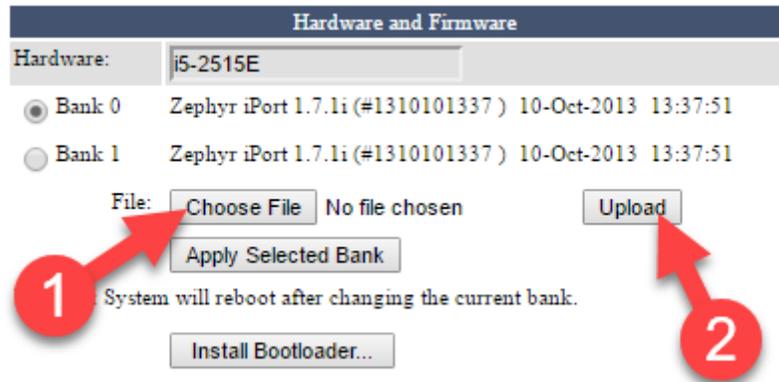
For installing this update, you will install from the System Page. From the System page, under “Hardware and Firmware” click on the Choose File button. (If you do not have a Choose File button, but have a Commit button, you would need to select Bank 1 and click the Commit button. This will free up Bank 1 for updating.) Browse to the location where the update file is stored, choose the file and then click Upload as shown below. The system will indicate that it is updating software and after a minute or two will indicate that the update is complete.

A couple of items of note: Your browser may not refresh itself automatically. If it doesn’t simply click on one of the other headers in the web page and then back on the System page. Also important to note is that after the Update, the version number shown in the unused bank will not change. If you received the message that the update was successful then everything is complete and your system is now ready to update to version 2.1. You do not need to reboot the iPort at this stage.

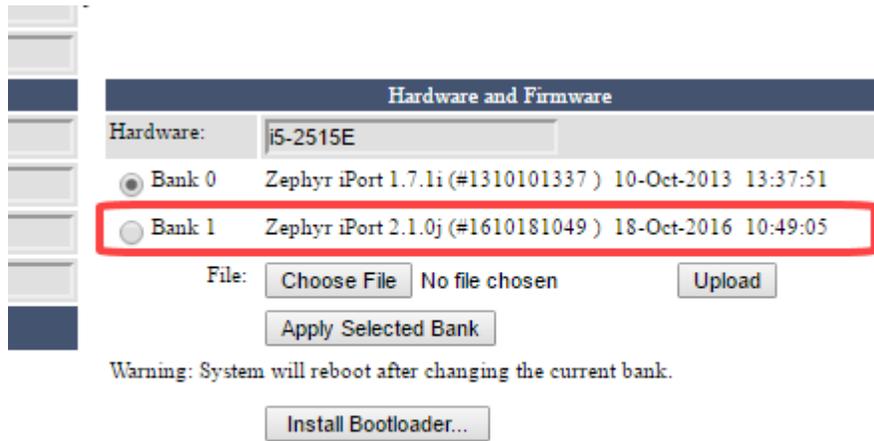
- 2) If your iPort is currently running 1.7 or higher, or if you have completed Step 1, then you may download and install the 2.1 iPort software release. The 2.1 update can be downloaded from here <ftp://ftp.zephyr.com/pub/Axia/Updates/iPort/1601-00535-016-iPort-2.1.0j.tar>. The upload steps are the same as in the previous step. Simply click on the Choose File button, select your file, and then click Upload. Once complete, you will see that Zephyr iPort 2.1.0j is now installed in Bank 1 as shown here.

To activate this Bank, simply click on and select Bank 1, and then click the Apply Selected Bank button. The system will ask you to confirm that you want to activate this bank and reboot the unit. Click YES to do it now, or NO if you intend to reboot later.
