Fanless Engine Update Instructions to version 3.2.2

August, 2019. Cleveland, Ohio USA

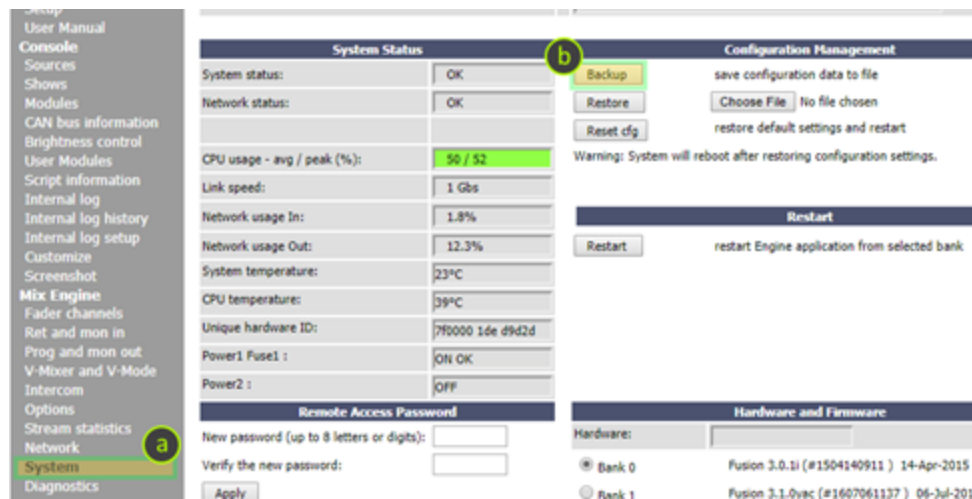
1. Take a backup of your configuration.
 - a. From the Mix Engine System page
 - b. press the Backup button and save the XML file to your PC

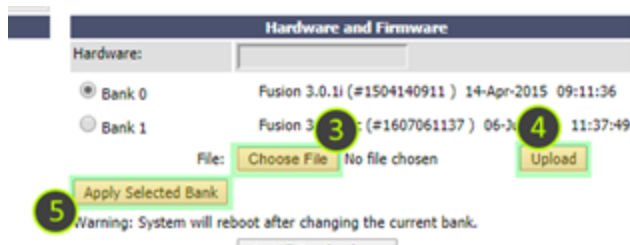
2. Make sure the active bank is Bank 0, if not press the “Commit” button.
3. Press the “Choose File” button and select the 3.2 update package that is located on your PC.
4. Press the “Upload” button to begin the update process. Wait for confirmation the process has completed and refresh the page.
5. Select Bank 1 radio button followed by the “Apply Selected Bank” button.
6. Provide confirmation when ready to reboot the Engine into the new software.
